Varec Biogas

Service Report Veolia water LLC Schenectady NY. WWTP

Attention: Paul La Fond, Monica Blount
Tel: 518-631-0037 X3002
Visit dates: 17 January, 2008
Subject: Site survey and repair.

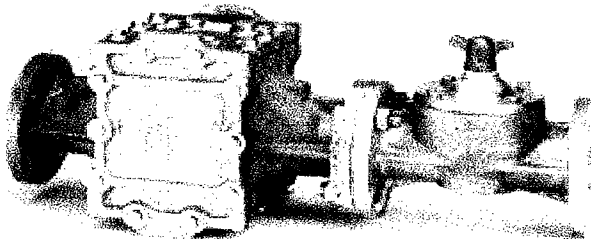
450

The original flame arrester location in relation to the boiler is ineffective and a new flame arrester would have to be located in a more practical location within 15 feet of the boiler. The 3" pipe above the boiler would be an ideal location for this application.

Here we recommend the installation of the Varec Biogas model 450, 3" flame trap assembly.

The assembly includes both the Varec Biogas 5000 series flame trap and model 430 thermal operated shut off valve. The combination of the two components is highly recommended for safe handling of biogas flowing to the boiler.

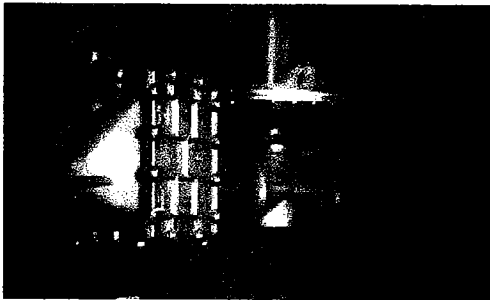
Installed here is the Varec Biogas model 440 back pressure regulator and flame trap assembly. Understanding this equipment to be twelve years old yet having never been serviced we elected to disassemble, inspect and clean both the flame arrester and valve.

With the help of your technicians we were eventually able to remove the flame bank assembly from the flame arrester casing. The flame bank assembly was partially cleaned then reinstalled however it does need to be replaced as soon as possible to ensure proper operation.

We removed, cleaned, inspected and reinstalled the back pressure regulator, thermal bypass valve, and regulator cap. The regulator cap has not been installed since the valves installation and without it the thermal bypass valve can not function properly. The regulator was recalibrated to seven (7) inches of water column. Both the regulator and flame trap assembly will require future routine maintenance in order to ensure optimal performance and efficiency of your system.

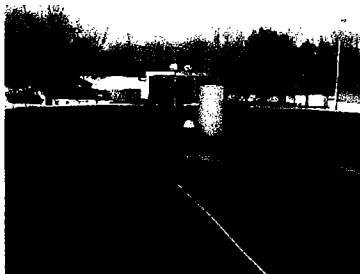
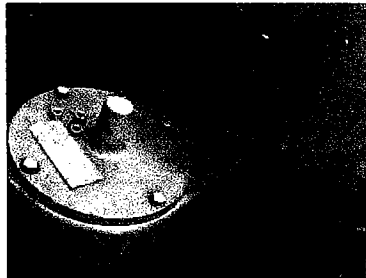
As previously mentioned there are two active anaerobic digesters at your facility able to produce usable biogas. The Varec Biogas four (4) inch pressure vacuum relief valves atop these digesters were in need of maintenance and both were directly mounted to the digester with no flame arresting capabilities in place. We disassembled and cleaned the pressure and vacuum relief valves and seats and installed new Teflon inserts, and reassembled all components.

The pressure relief pallets should be replaced as they were out of shape and unable to provide an adequate seal to the seat. We also highly recommend the 2011 "All Weather" PVR valves be installed with the Varec Biogas 5000 series flame arresters and add insulating blankets to the entire assemblies. The flame arrester prevents the propagation of flame or flame flash back and the insulating blankets protect from ice and snow during winter months.
